**Flood Control Project Maintenance
Levee Inspections**
LMA District Cover Sheet
Spring 2017 Levee Inspection Results

Reclamation District No. 1600 Mull

Spring 2017 Levee Inspection Results

| Waterway | | | Bank | Unit Miles |
|--|---|---|---|---|
| Unit No. 01 Sacramento River | | | Right | 10.46 |

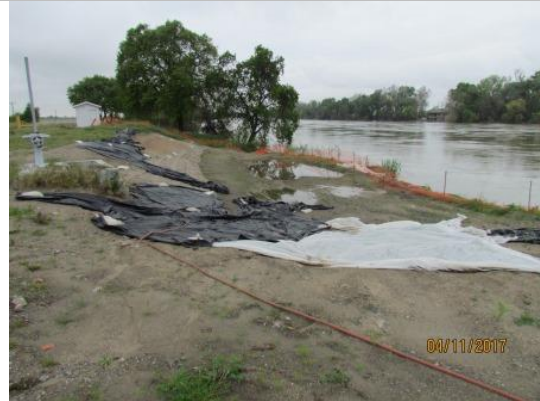
Photo 1 of 1 : SP_2017_RD1600_191_25_20170413_00123.jpg

Runoff erosion on waterside levee slope. LMA placed visqueen to prevent further erosion. Spring 2017.

| E2 : Schedule repair of erosion site prior to the next inspection. | | | | | |

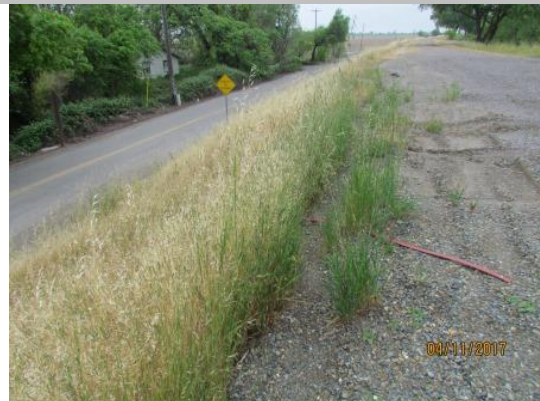
Photo 1 of 1 : SP_2017_RD1600_191_39_20170413_00124.jpg

Tall grass on landside levee slope, blocking visibility. Spring 2017.

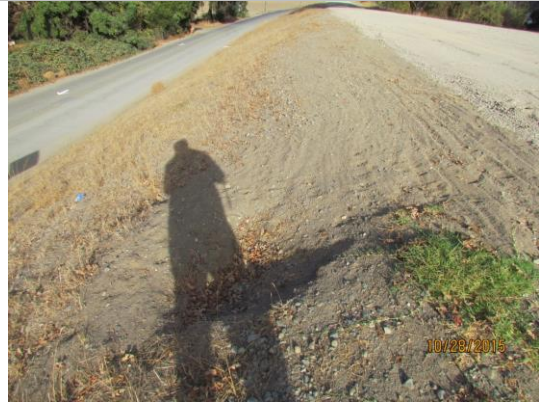
Photo 1 of 1 : SP_2017_RD1600_191_38_20170320_00043.jpg

View of a slope depression on the landward side of the levee looking downstream. Fall 2015.

| S3 : Repair the levee slope damaged by vehicle traffic and prevent access where possible. | | | | | |

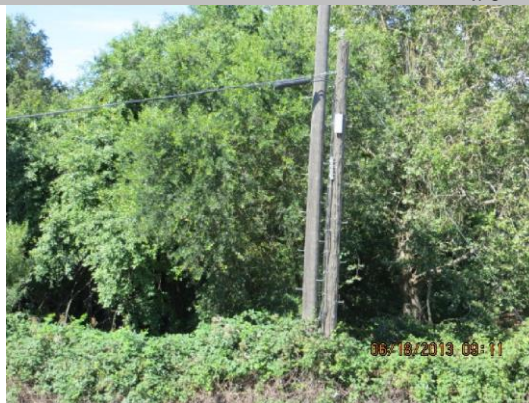
Photo 1 of 1 : UCIP_SP_2017_15087_24812.jpg

| FS_ID:15087 DS_ID:21459 EP_NO: 1929 Repair Type: Non-Urgent Crossing Status: Indicator Found UCIP Comments: Line should be located with carsonite signs on both sides of levee. FIELD_STRUCT_DESC: Telephone cable through levee 3.0 feet below crown. Telephone line at JP off LS toe (Permit No. 1929, 1959). FS Date: 6/18/2013 | | | | | |

Line visible on JP off LS toe. Likely this is the source of crossing.

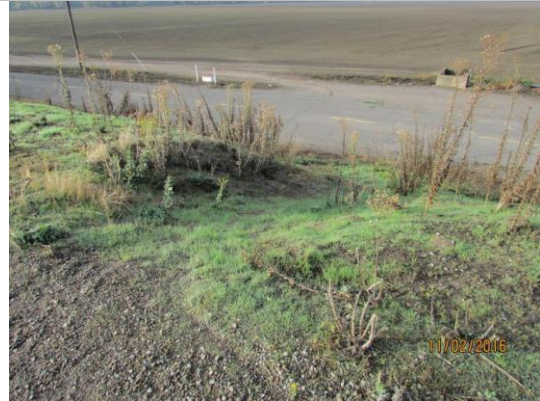
Photo 1 of 2 : SP_2017_RD1600_191_133_20170320_00082.jpg

Updated view of the slope stability site. Fall 2016.

| S2 : Repair the levee slope damaged by foot traffic and prevent access where possible. | | | | | |

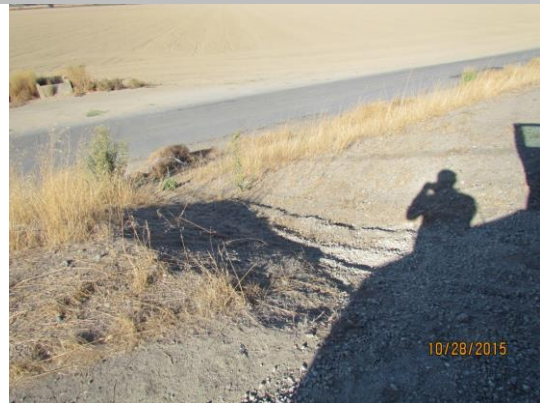
Photo 2 of 2 : SP_2017_RD1600_191_133_20170320_00083.jpg

View of the slope stability on the landward side of the levee. Fall 2015.

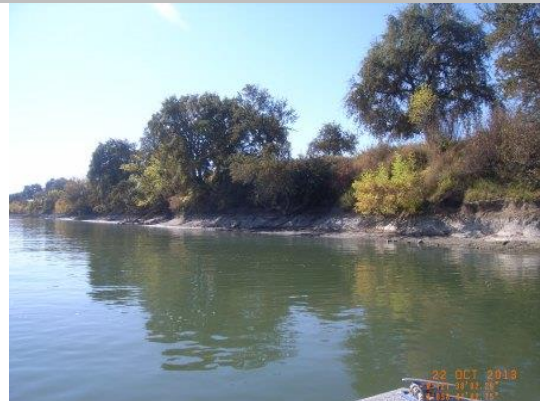
Photo 1 of 1 : SP_2017_RD1600_191_7_20170320_00012.jpg

| 2000 - Very cohesive vertical bank. 2003 - Some minor new erosion. 2006 - Some minor erosion in old pockets. 2009 - Minimal new erosion. 2011 - Multiple new erosion pockets and a few new tree popouts. 2015: No observed changes. [2015 Site ID: SAC_71-3_R] | | | | | |

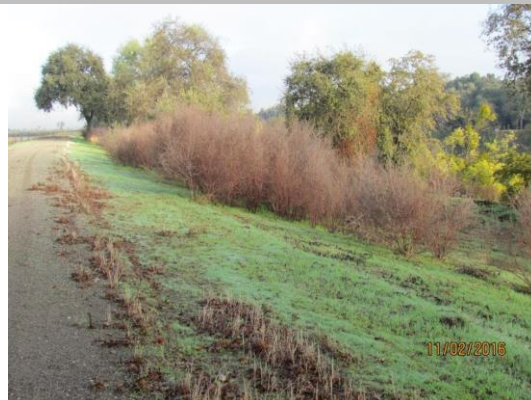
Photo 3 of 3 : SP_2017_RD1600_191_29_20170320_00035.jpg

Updated view of willows on waterward side. Fall 2016.

| Recommend removal of willow trees. | | | | | |

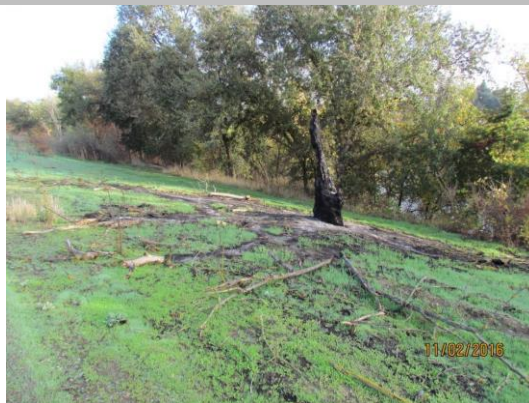
Photo 2 of 2 : SP_2017_RD1600_191_624_20170320_00089.jpg

Dying tree on waterward side was burnt. Fall 2016.

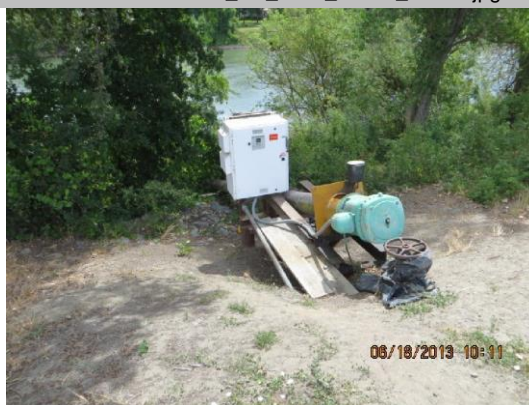
Photo 2 of 3 : UCIP_SP_2017_15285_25087.jpg

| FS_ID:15285 DS_ID:21463 EP_NO: 6100 Repair Type: Non-Urgent Crossing Status: Found UCIP Comments: Gate valve will not open or close. FIELD_STRUCT_DESC: 12-inch pipe through levee 3.4 feet below crown. Slant pump and gate valve on the waterward- slope. Siphon breaker in 12-inch steel riser on the landward shoulder. Filter, booster pump, and butterfly valve on LS toe. 2.25-inch galvanized iron electrical conduit at same location (Permit No. 6100, 1968). Replaced 8-inch pipe at same location. FS Date: 6/18/2013 | | | | | |

Pump and gate valve on WS slope.

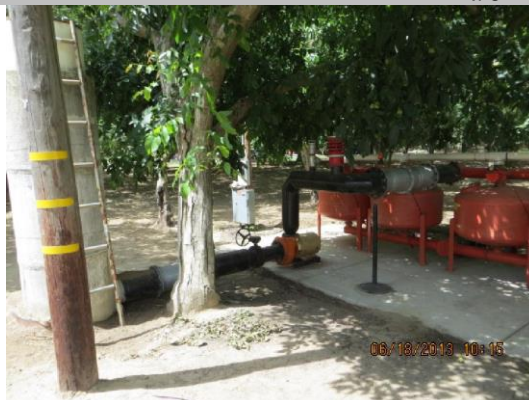
Photo 3 of 3 : UCIP_SP_2017_15285_25086.jpg

| FS_ID:15285 DS_ID:21463 EP_NO: 6100 Repair Type: Non-Urgent Crossing Status: Found UCIP Comments: Gate valve will not open or close. FIELD_STRUCT_DESC: 12-inch pipe through levee 3.4 feet below crown. Slant pump and gate valve on the waterward- slope. Siphon breaker in 12-inch steel riser on the landward shoulder. Filter, booster pump, and butterfly valve on LS toe. 2.25-inch galvanized iron electrical conduit at same location (Permit No. 6100, 1968). Replaced 8-inch pipe at same location. FS Date: 6/18/2013 | | | | | | |

Filters, boost pump, and gate valve down stream from concrete standpipe off LS toe.

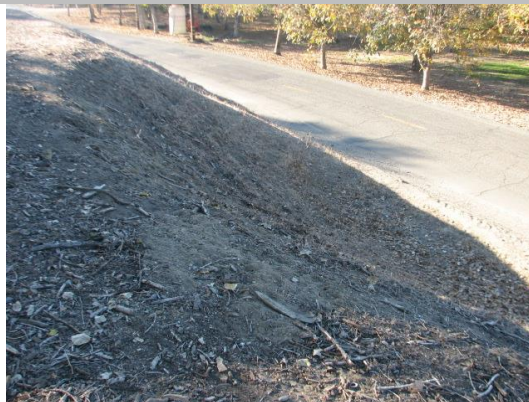
Photo 1 of 2 : SP_2017_RD1600_191_134_20170320_00084.jpg

The levee has a deep depression caused by removed tree. Fall 2013

| S1 : Repair slope instability. | | | | | |

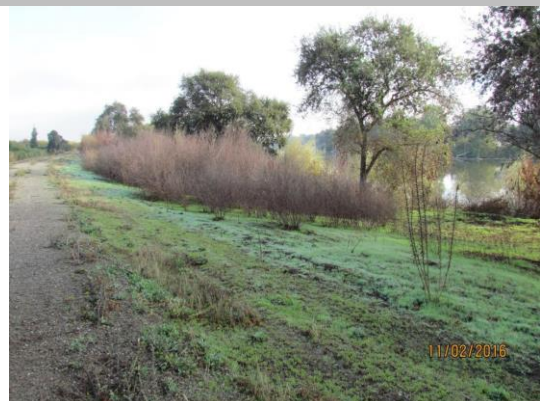
Photo 1 of 1 : SP_2017_RD1600_191_50_20170320_00054.jpg

View of willows on waterward side of the levee. Recommended removal. Fall 2016.

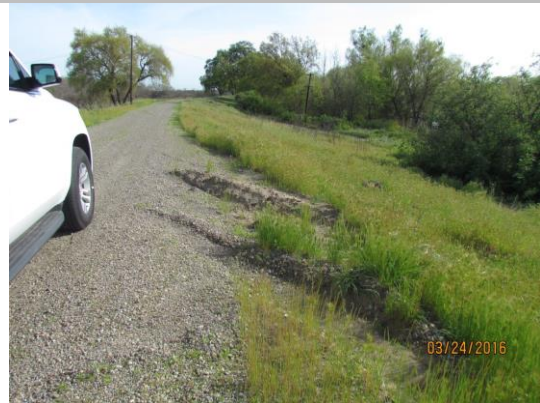
Photo 1 of 1 : SP_2017_RD1600_191_71_20170320_00073.jpg

View of the ruts on the shoulder of the levee on the waterward side.
Spring 2016.

| S3 : Repair the levee slope damaged by vehicle traffic and prevent access where possible. | | | | | |

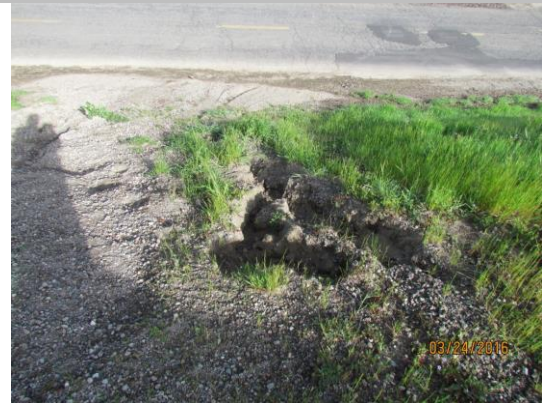
Photo 1 of 4 : SP_2017_RD1600_191_72_20170320_00074.jpg

| Erosion seems to be caused by rain runoffs. Slope is graveled. Unsure if it is being used as a ramp. | | | | | |

Erosion is on the landward side of the levee about midway from the shoulder of the levee. Spring 2016.

| E2 : Schedule repair of erosion site prior to the next inspection. | | | | | |

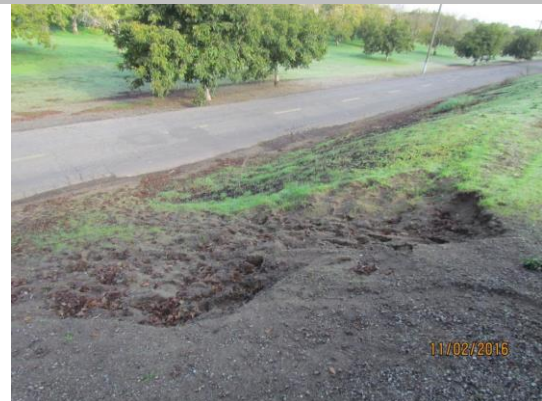
Photo 2 of 4 : SP_2017_RD1600_191_72_20170320_00075.jpg

Updated view of the erosion site. Fall 2016.

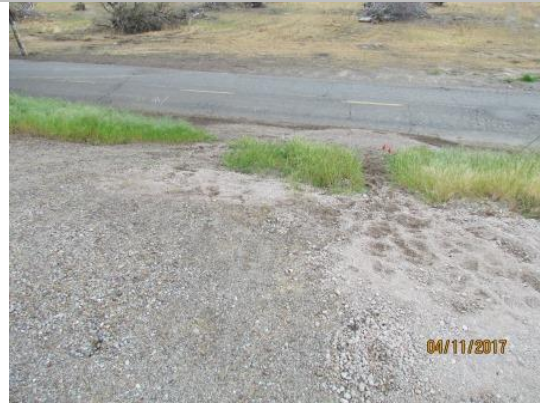
Photo 4 of 4 : SP_2017_RD1600_191_72_20170413_00126.jpg

| Erosion seems to be caused by rain runoffs. Slope is graveled. Unsure if it is being used as a ramp. | | | | | | |

Updated view of the erosion site. Spring 2017.

| E2 : Schedule repair of erosion site prior to the next inspection. | | | | | | |

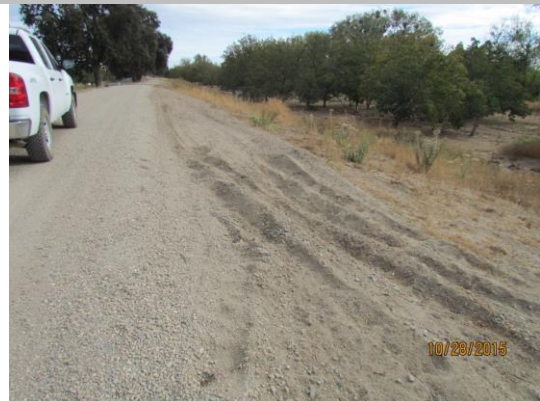
Photo 1 of 1 : SP_2017_RD1600_191_52_20170320_00056.jpg

View of the slope stability caused by vehicles on the waterward side of the levee looking upstream. Fall 2015.

| S3 : Repair the levee slope damaged by vehicle traffic and prevent access where possible. | | | | | |

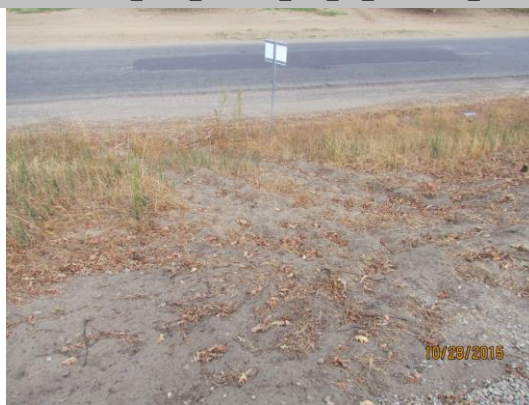
Photo 1 of 1 : SP_2017_RD1600_191_55_20170320_00059.jpg

View of the slope stability damaged by vehicles on the landward side of the levee. Fall 2015.

| S3 : Repair the levee slope damaged by vehicle traffic and prevent access where possible. | | | | | |

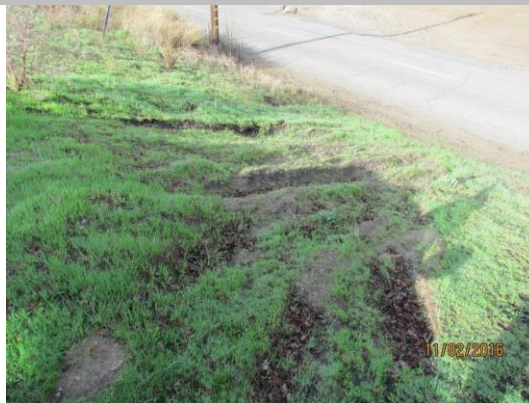
Photo 1 of 1 : SP_2017_RD1600_191_43_20170320_00047.jpg

LS slope damaged by a vehicle. Fall 2016.

| S3 : Repair the levee slope damaged by vehicle traffic and prevent access where possible. | | | | | |

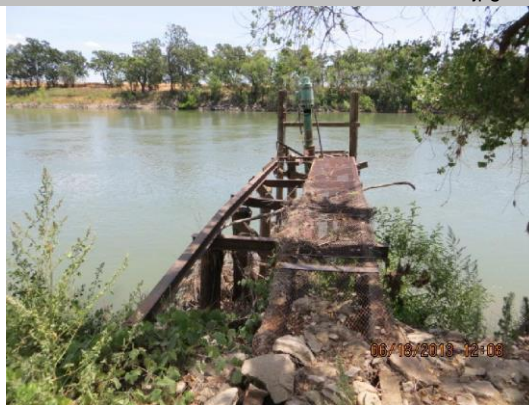
Photo 2 of 3 : UCIP_SP_2017_15108_24825.jpg

Debris buildup at metal platform waterline.

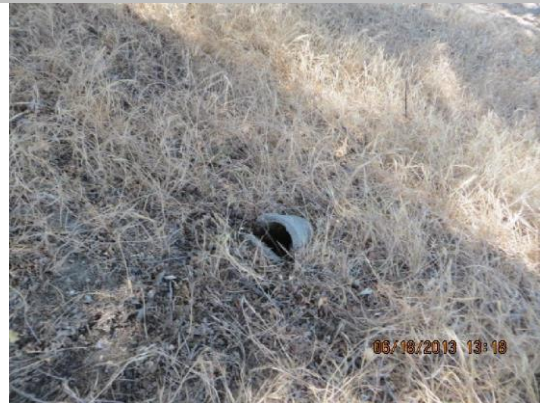
Photo 1 of 2 : UCIP_SP_2017_15110_24828.jpg

| FS_ID:15110 DS_ID:21490 EP_NO: N/A Repair Type: Non-Urgent Crossing Status: Indicator Found UCIP Comments: Abandoned and should be removed from levee. FIELD_STRUCT_DESC: *ABANDONED* 10-inch concrete pipe through levee 5.0 feet below crown. Pipe visible on LS slope. Originally included in the 1955 O&M manual. FS Date: 6/18/2013 | | | | | |

Pipe visible on LS slope.

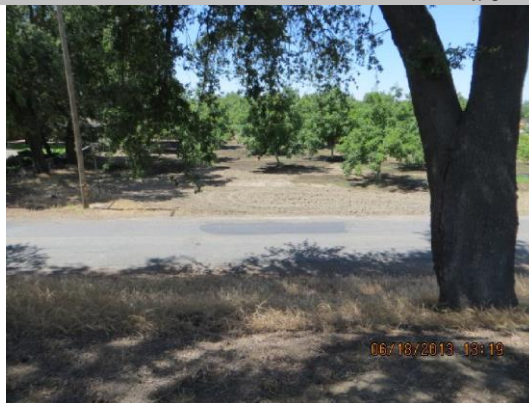
Photo 2 of 2 : UCIP_SP_2017_15110_24827.jpg

| FS_ID:15110 DS_ID:21490 EP_NO: N/A Repair Type: Non-Urgent Crossing Status: Indicator Found UCIP Comments: Abandoned and should be removed from levee. FIELD_STRUCT_DESC: *ABANDONED* 10-inch concrete pipe through levee 5.0 feet below crown. Pipe visible on LS slope. Originally included in the 1955 O&M manual. FS Date: 6/18/2013 | | | | | |

Pipe visible on LS slope.

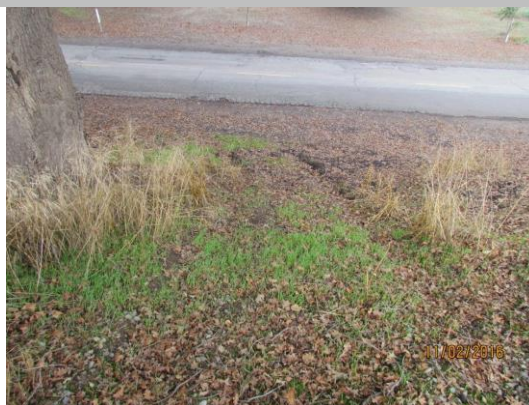
Photo 1 of 1 : SP_2017_RD1600_191_47_20170320_00050.jpg

LS levee slope damaged by a vehicle. Fall 2016.

| S3 : Repair the levee slope damaged by vehicle traffic and prevent access where possible. | | | | | |

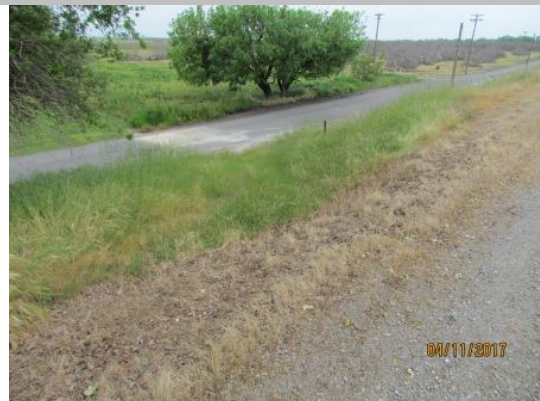
Photo 1 of 1 : SP_2017_RD1600_191_76_20170413_00128.jpg

Slope depression on landside levee slope from vehicle traffic. Spring 2017.

| S3 : Repair the levee slope damaged by vehicle traffic and prevent access where possible. | | | | | |

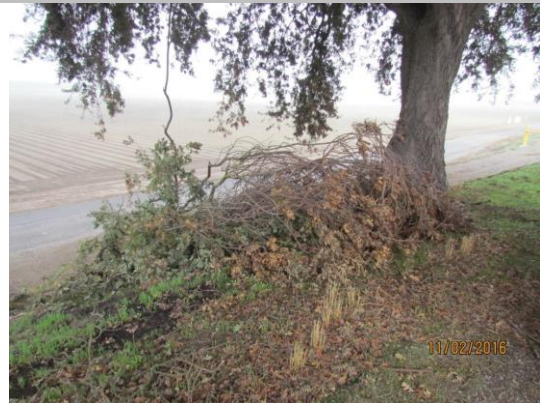
Photo 1 of 1 : SP_2017_RD1600_191_54_20170320_00058.jpg

Prunings on landside slope. Fall 2016.

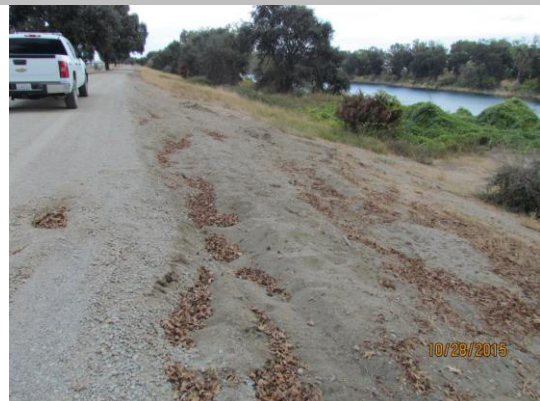
Photo 1 of 1 : SP_2017_RD1600_191_67_20170320_00070.jpg

View of the shoulder damaged by vehicles on the waterward side of the levee looking upstream. Fall 2015.

| S3 : Repair the levee slope damaged by vehicle traffic and prevent access where possible. | | | | | |

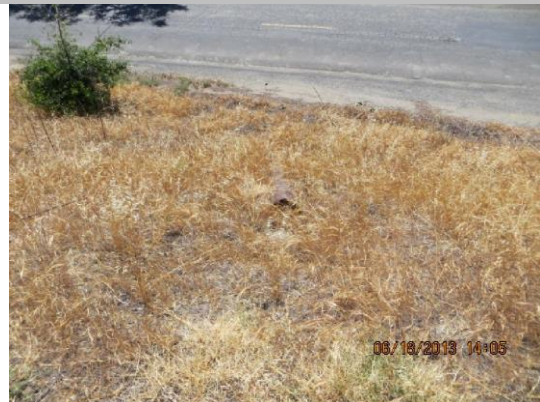
Photo 1 of 2 : UCIP_SP_2017_41563_27474.jpg

| FS_ID:41563 DS_ID:21471 EP_NO: N/A Repair Type: Non-Urgent Crossing Status: Found UCIP Comments: Pipe should be removed from slope. FIELD_STRUCT_DESC: *ABANDONED* 12-inch pipe through the levee 5.5 feet below the crown. Grouted in place 1957. FS Date: 6/18/2013 | | | | | |

Pipe and remnants of grouted pipe on LS slope.

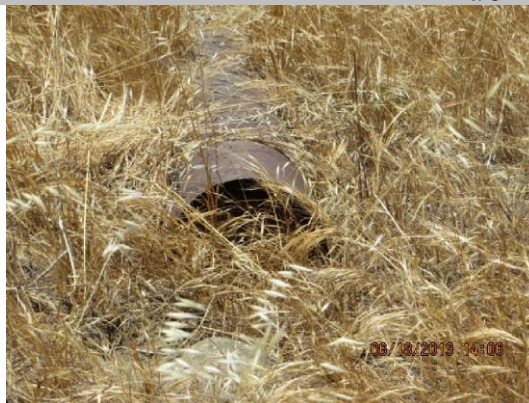
Photo 2 of 2 : UCIP_SP_2017_41563_27473.jpg

Pipe and remnants of grouted pipe on LS slope.

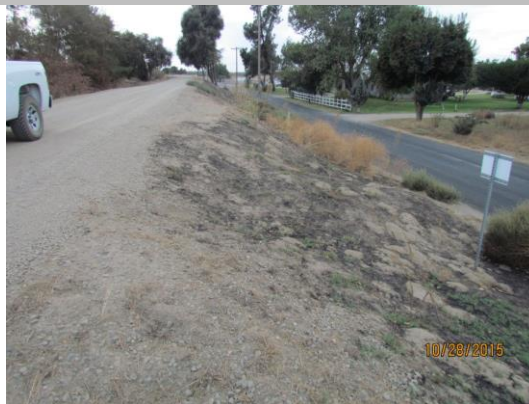
Photo 1 of 1 : SP_2017_RD1600_191_41_20170320_00045.jpg

View of the bulge at the toe of the levee on the landward side looking downstream. Fall 2015.

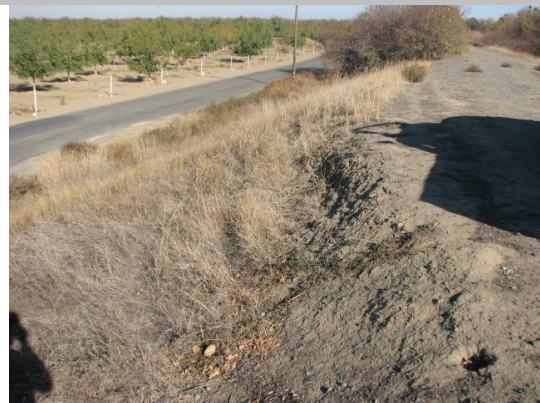
Photo 1 of 2 : SP_2017_RD1600_191_141_20170320_00086.jpg

The erosion at the shoulder of the levee could be slope instability. Fall 2013

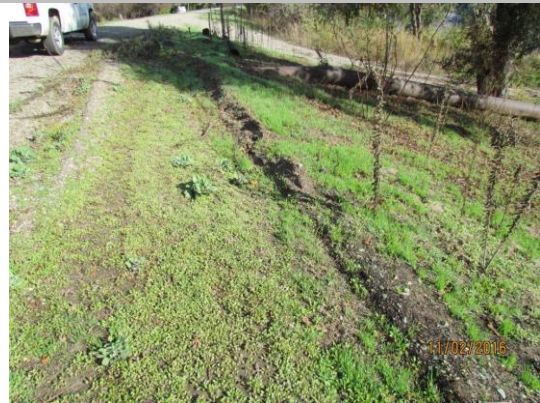
Photo 1 of 1 : SP_2017_RD1600_191_44_20170320_00048.jpg

View of WS slope depression. Fall 2016.

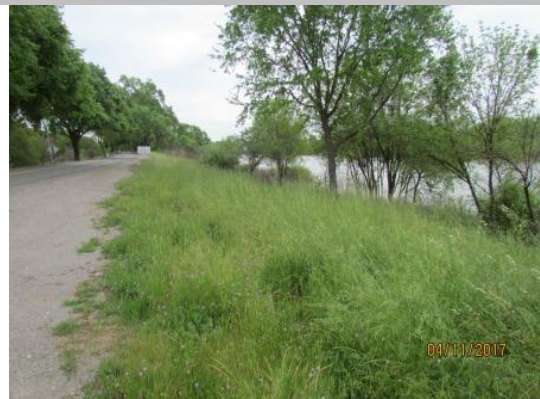
Photo 1 of 1 : SP_2017_RD1600_191_79_20170413_00130.jpg

Tall grass on waterside levee slope, blocking visibility. Spring 2017.

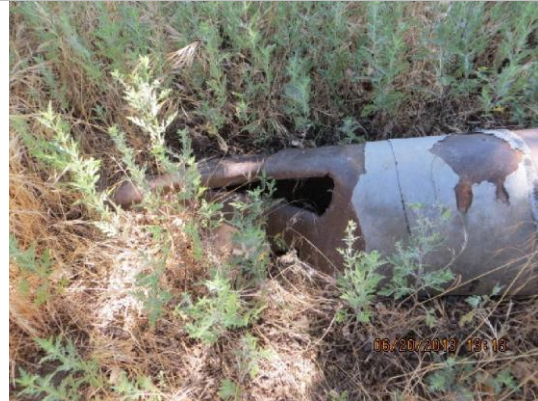
Photo 3 of 3 : UCIP_SP_2017_50101_25009.jpg

Hole in pipe at WS toe.

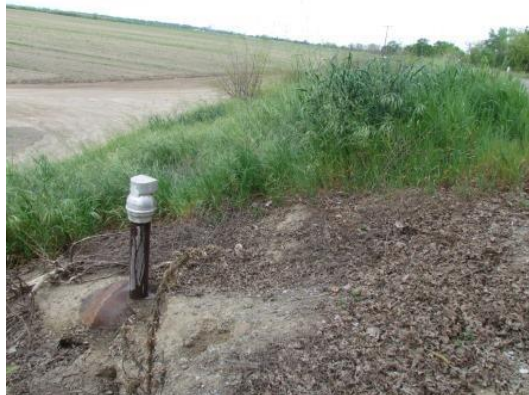
Photo 1 of 2 : SP_2017_RD1600_191_1199_20170320_00097.jpg

View of erosion and pipe on the landward side of the levee looking upstream. Spring 2015.

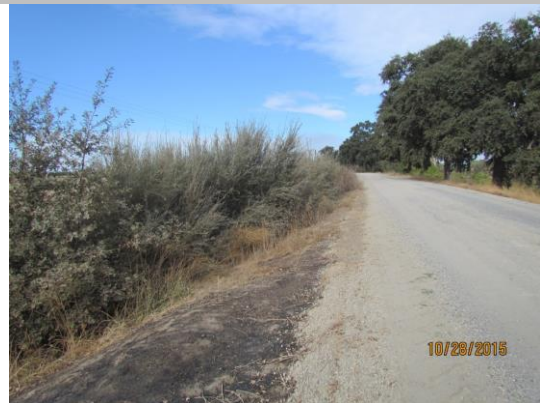
Photo 2 of 2 : SP_2017_RD1600_191_631_20170320_00096.jpg

View of the brush and vegetation on the landward side of the levee. Fall 2015.

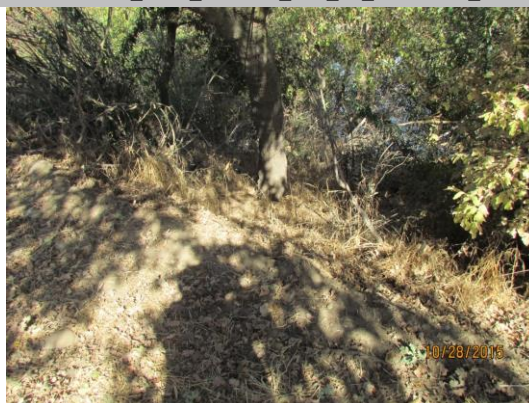
Photo 4 of 5 : SP_2017_RD1600_191_20_20170320_00019.jpg

Looking at the erosion site on the berm. Fall 2015.

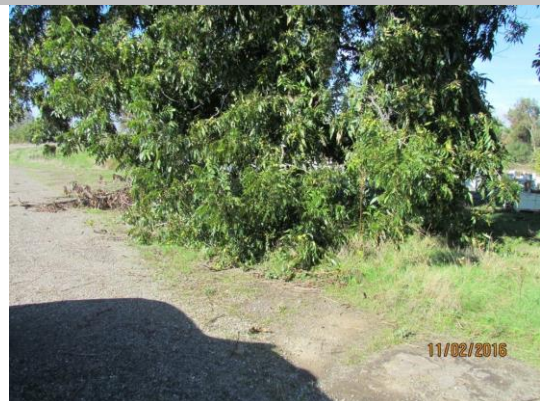
Photo 1 of 1 : SP_2017_RD1600_191_63_20170320_00067.jpg

Tree trimming on WS slope is needed. Fall 2016.

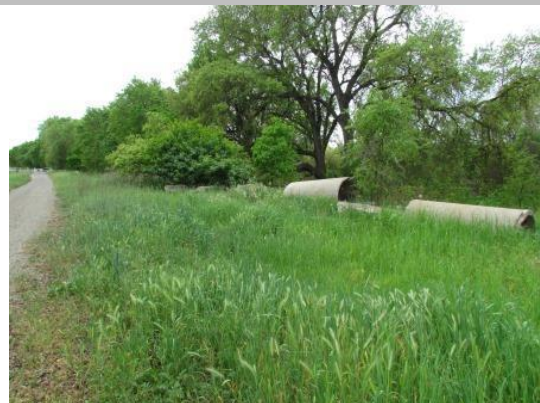
Photo 1 of 1 : SP_2017_RD1600_191_1202_20170320_00101.jpg

View of debris on the waterward side of the levee looking upstream.
Spring 2015.

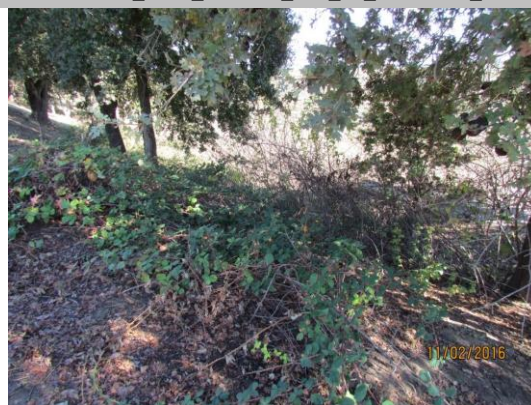
Photo 1 of 1 : SP_2017_RD1600_191_74_20170320_00079.jpg

Tree thinning on LS slope is needed. Fall 2016.

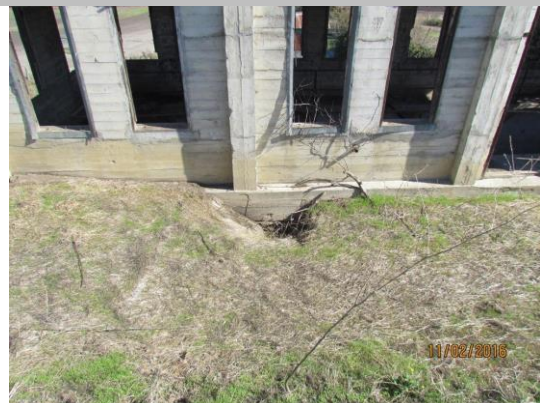
Photo 1 of 1 : SP_2017_RD1600_192_4_20170320_00003.jpg

Landside levee slope erosion at RD1600 pumping plant. Fall 2016.

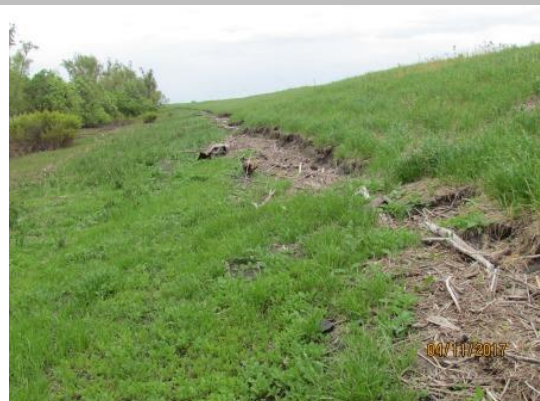
Photo 1 of 1 : SP_2017_RD1600_192_23_20170413_00032.jpg

View of wave wash damage on waterside levee slope. Spring 2017.

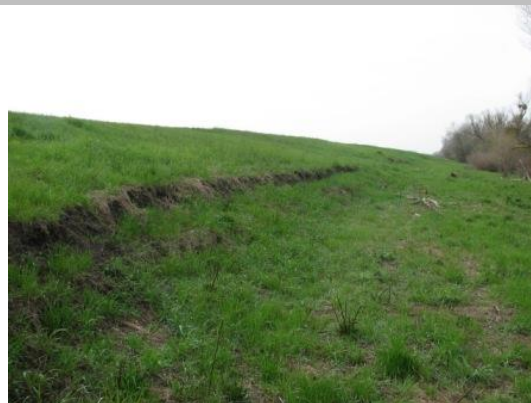
Photo 1 of 4 : SP_2017_RD1600_192_14_20170320_00012.jpg

A closer view of the wave wash damage along the bypass.

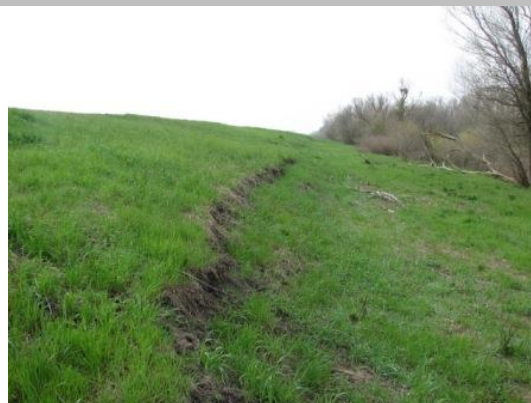
Photo 2 of 4 : SP_2017_RD1600_192_14_20170320_00013.jpg

Wave wash damage along the slope the cut is 1'-2'.

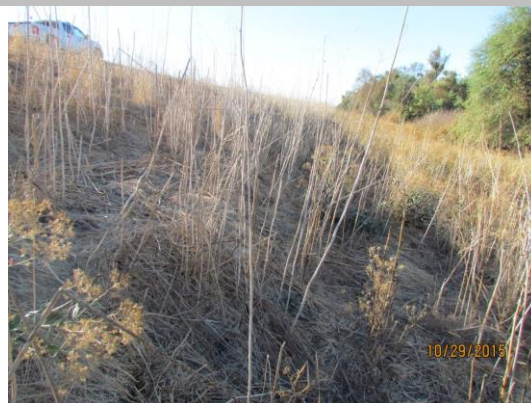
Photo 3 of 4 : SP_2017_RD1600_192_14_20170320_00014.jpg

View of the erosion on the waterward side of the levee looking downstream. Fall 2015.

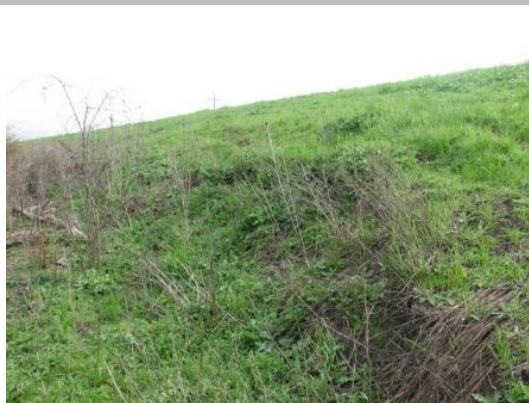
Photo 1 of 3 : SP_2017_RD1600_192_15_20170320_00016.jpg

Looking upstream a deeper cut of 2'-3' damage.

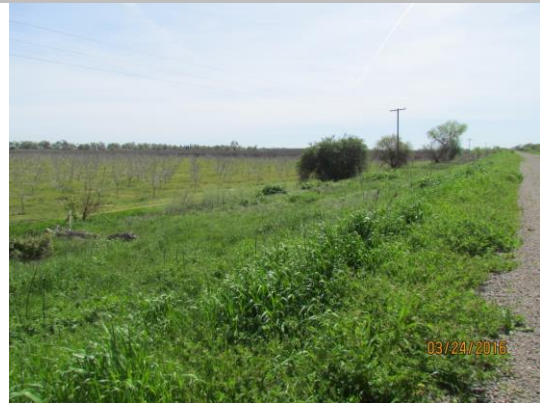
Photo 2 of 2 : SP_2017_RD1600_192_2_20170320_00002.jpg

View of the fallen tree on the landward side of the levee looking downstream. Spring 2016.
